Evaluation the efficiency of mechanical and/or chemical cleaning methods of endodontic sealer remanent of the pulp chamber dentine and its effect on the bond strength of composite restoration by micro tensile bond strength

Abstract:

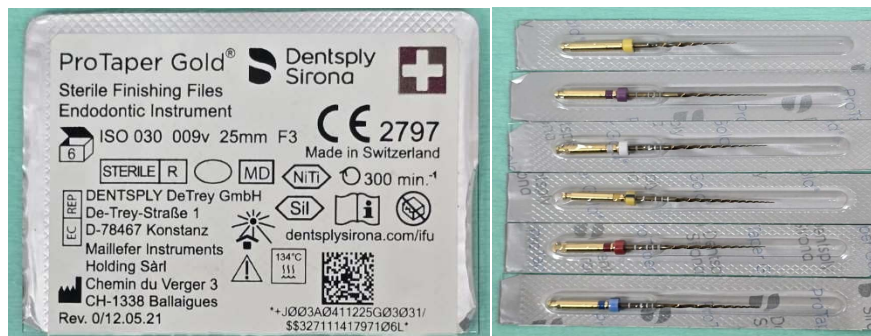
Figure (1): A photograph showing the ProTaper Gold rotary instruments.

ProTaper Gold (figure 1) rotary tools (Dentsply Maillefer, Ballaigues, Switzerland) were used for preparation the root canals, and 5,25% NaOCl was used as an irrigation solution. The final tool employed in the apical area was an F3 finishing file.

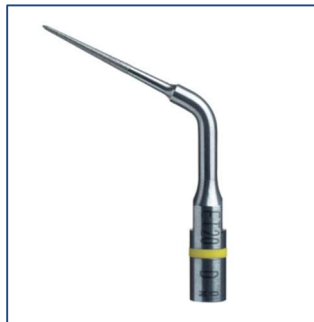
Figure (2): A photograph showing Acteon ET20D - Diamond Canal Prob. Tip used in Group 1.

The contaminated dentin surface was accomplished utilizing an Acteon ET20D - Diamond Canal Prob. Use an ultrasonic tip (P5 Newtron, Satelec Acteon, Merignac, France) for 20 seconds, making pressure-free encountering the surface (figure 2).

The current research employed the endodontic tip ET 20D because it is frequently utilized in root canal treatment for access preparation, calcified dentin removal, and orifice location. We used acetone to decontaminate the dentine with sealant and found that acetone produced a stronger binding than ethanol. ⁽²⁰⁾

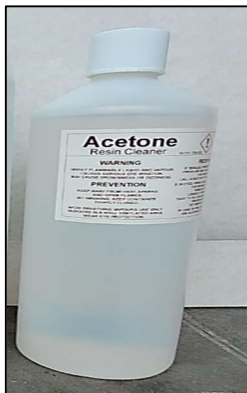
Figure (3): A photograph showing Acetone - Resin Cleaner used in Group 2.

The contaminated dentin surface was removed by utilizing 99.5% acetone-saturated cotton pellets - Resin Cleaner (RPM Supplies Ltd: 46 Western Parkway Business Park, Lower Ballymount Road, Ballymount, Dublin 12, Republic of Ireland) for 20 seconds till a stereomicroscope image revealed no sealant on the dentine surface (figure 3).

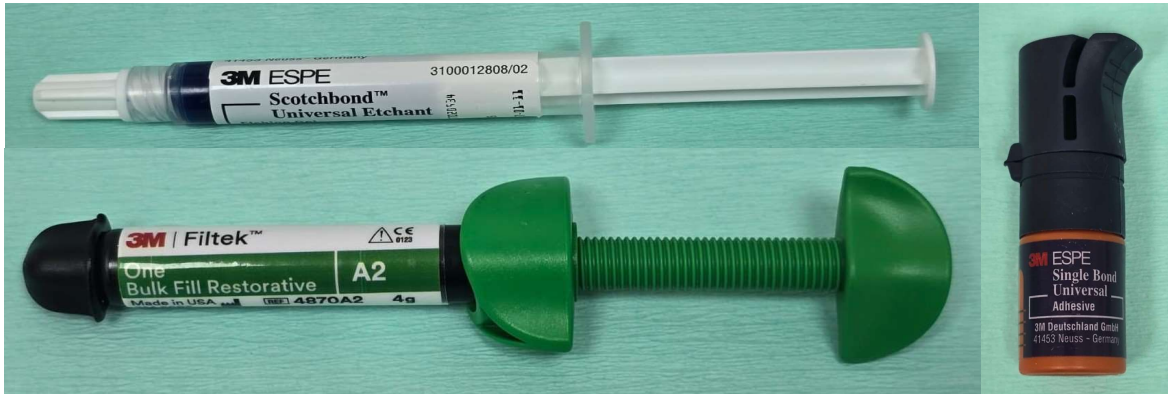
Figure (4): A photograph showing the composite used for pulp chamber restoration.

The dentine surfaces were coated with a self-etch adhesive approach (3M ESPE, USA) in accordance with the directions provided by the supplier. A 3 mm Single-layer of composite resin 3M™ Filtek™ One Bulk Fill Restorative (3 M ESPE, St. Paul, MN, USA) were placed on the dentine surface and cured at ambient temperature. The composite was then exposed to light for 20 seconds utilizing a VALO (Ultradent) LED light-curing device (LCU) that had an irradiance of 1000 mW/cm². For a whole day, repaired molars were kept in water at 37°C (figure 4).

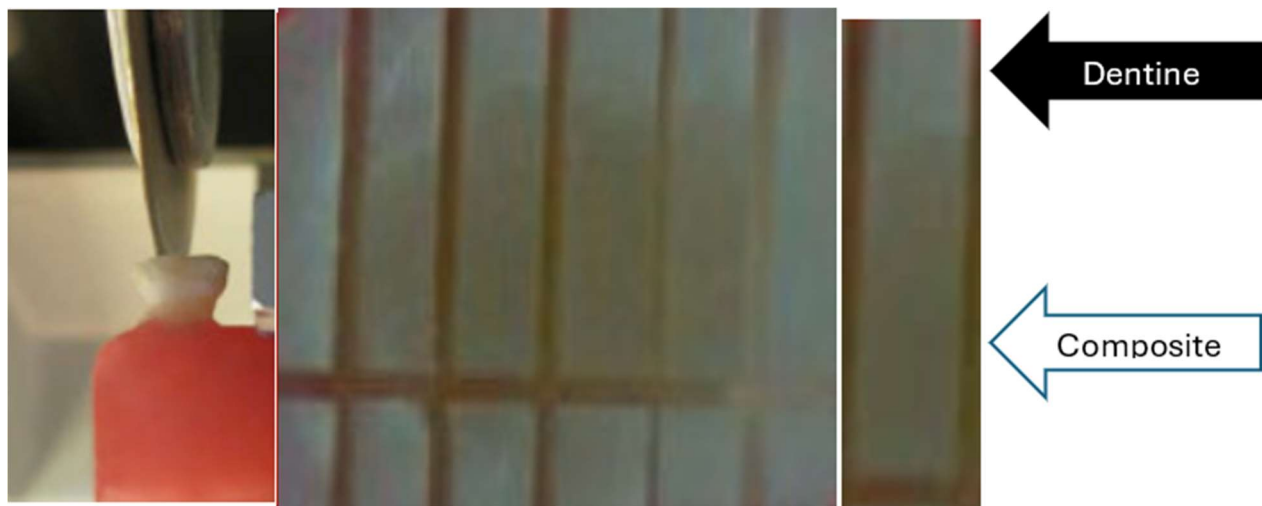
Figure (5): A photograph showing preparing a specimen to be measured by the Micro-tensile bond strength.

Three rods were used for each tooth. The samples were inspected optically and then assessed using Leica stereomicroscopy (model S8APO, LAS 3.4 software) at a magnification of 20×. Thirty sticks from each group were selected with total of 120 sticks were selected from all groups for the μ TBS test⁽¹⁴⁾ (figure 5).

Using cyanoacrylate adhesive, every sample was attached to a Geraldelli jig and tensioned (using a Micro-tensile tester from Isomet, USA) at a 1 mm/min crosshead speed until failure⁽¹⁵⁾. Bond strengths were computed by dividing the force applied until failure by the cross-sectional bonding region. Mega Pascals were used to compute bond strength and was measured in Newtons.

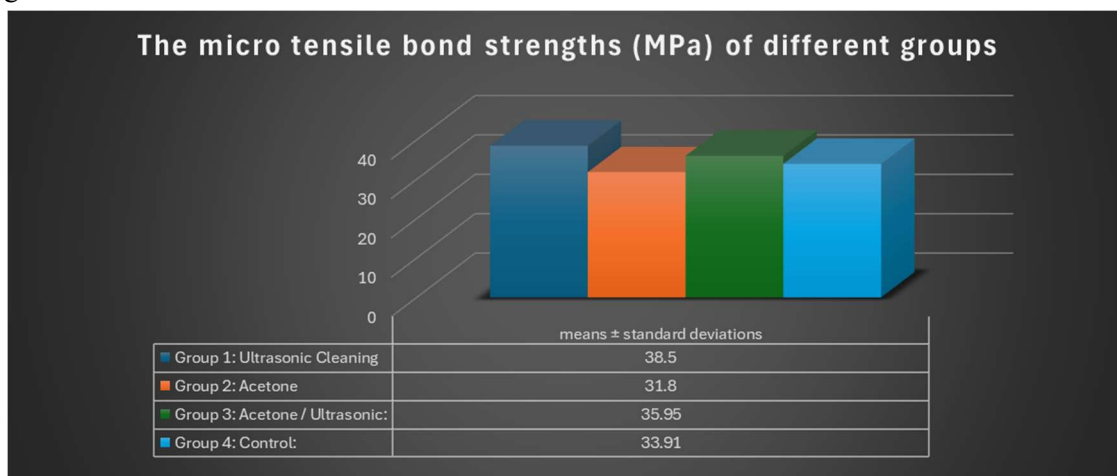
Figure (6): A photograph showing the μ -TBS means values

The means and standard deviations of micro tensile bond strength were represented in Table (1) and illustrated in Figure (6) while the failure modes by (%) of different groups were represented in Table (2) and Figure (7).

Group 1 (Ultrasonic Cleaning) had the greatest reported μ -TBS (**38.50 ± 7.91**), while the lowest μ -TBS was reported in **Group 2 (Acetone)** **31.80 ± 7.42** with statistically significant different (p = 0.007).

On other hand **Group 1(Ultrasonic Cleaning), and Group 3 (Acetone / Ultrasonic)** showed results similar to the results of **Control Group with no** statistically significant different (P > 0.05).

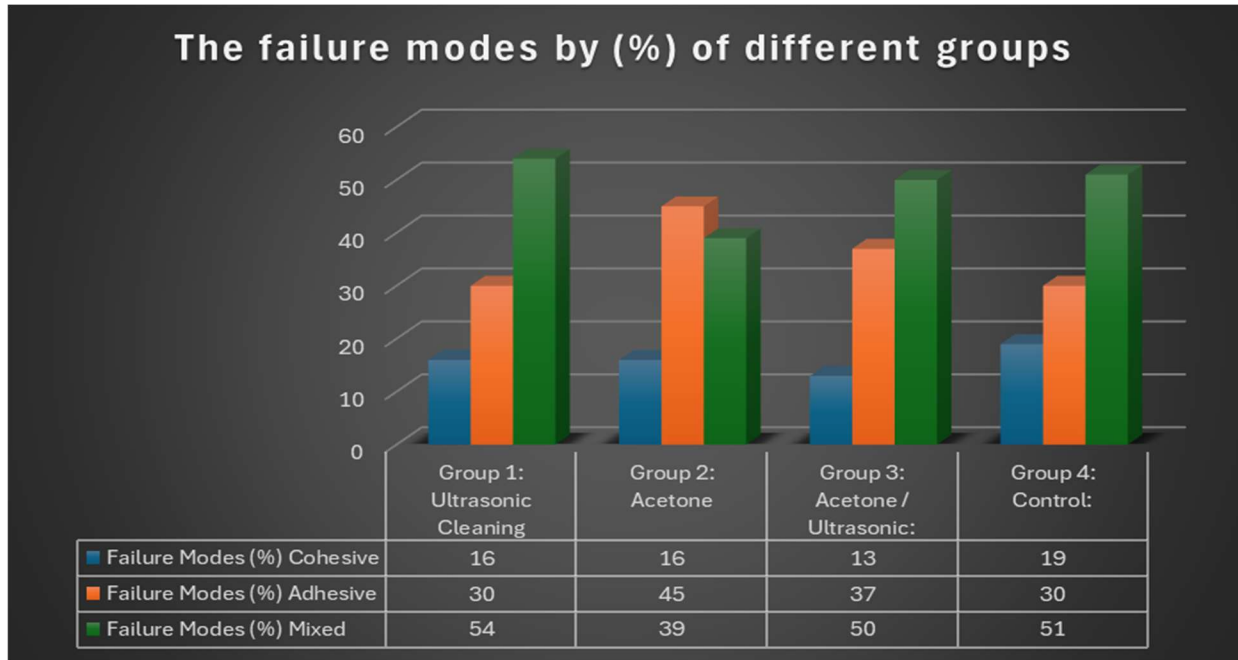
Figure (7): A photograph showing the failure modes by (%) of different groups.

In concerning the distribution of failure mode, showed that the mixed-type failure mode (54%) was the most common one seen in **Group 1 (Ultrasonic Cleaning)**, (51%) recorded in **Group 4 (Control)**, (50%) recorded in **Group 3 (Acetone / Ultrasonic)**, and the lowest was (39%) recorded in **Group 2 (Acetone)**. While the distribution of adhesive failure mode was (45%) recorded in groups **Group 2 (Acetone)**, (37%) recorded in

Group 3 (Acetone / Ultrasonic), and (30%) recorded in both Group 1(Ultrasonic Cleaning) & Group 4 (Control).
